[Docket No. 93-CE-54-AD; Amendment 39-9665; AD 96-12-22]

Airworthiness Directives; Cessna Aircraft Company Engine Oil Filter Adapter Assemblies Installed on Aircraft

96-12-22 CESSNA AIRCRAFT COMPANY : Amendment 39-9665; Docket No. 93-CE-54-AD.

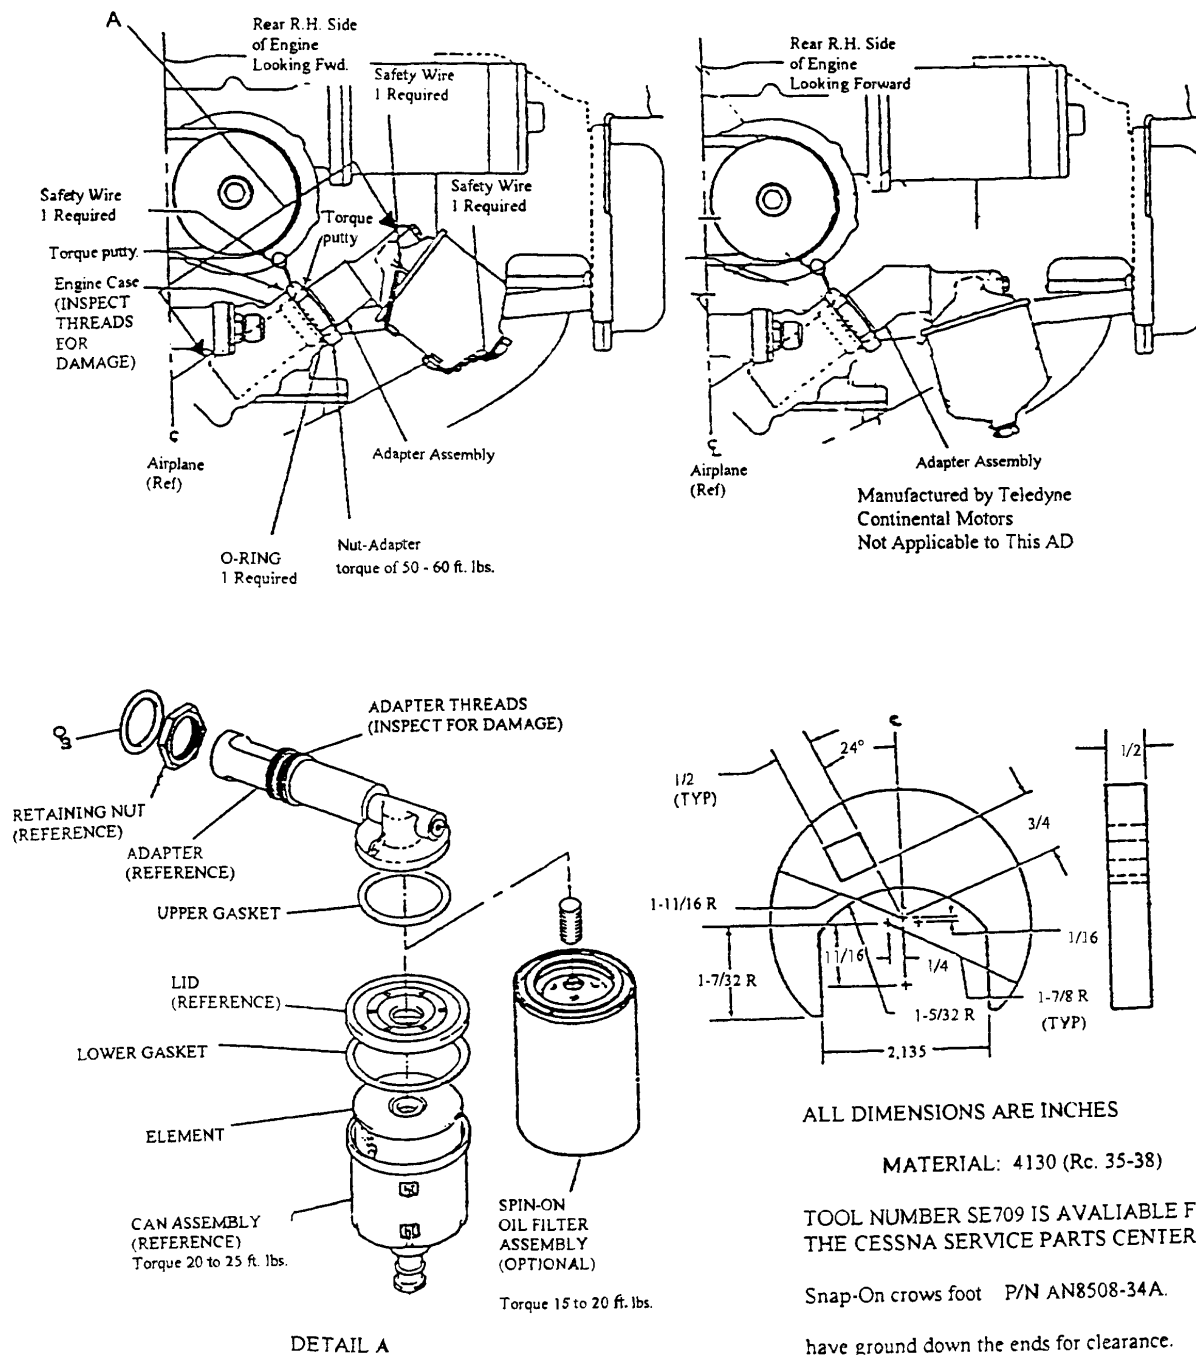
Figure 1. Oil Filter Adapter Installation
AD 96-12-22

NOTE 2: This AD does not apply to engine oil filter adapter assemblies manufactured by Teledyne Continental Motors (See Figure 1 of this AD).

(a) For airplanes with engine oil filter adapter assemblies that do not have torque putty between the engine filter adapter assembly, nut, and oil pump housing, accomplish the following:

(4) Apply torque putty between the engine filter adapter assembly, nut, and oil pump housing as specified in Figure 1 of this AD.
